NordTank N65 Inspection Medicine Bow, Wyoming

Prepared for: Analogic Engineering, Inc.

Prepared by: Ryan Dela
Energy Maintenance Service, LLC
8/14/2005

On August 13, 2005 Energy Maintenance Service, LLC staff climbed and inspected a Nordtank N65 Wind Turbine Generator located near Medicine Bow, Wyoming. The contents of this report summarize in general detail the findings of that climb and inspection.

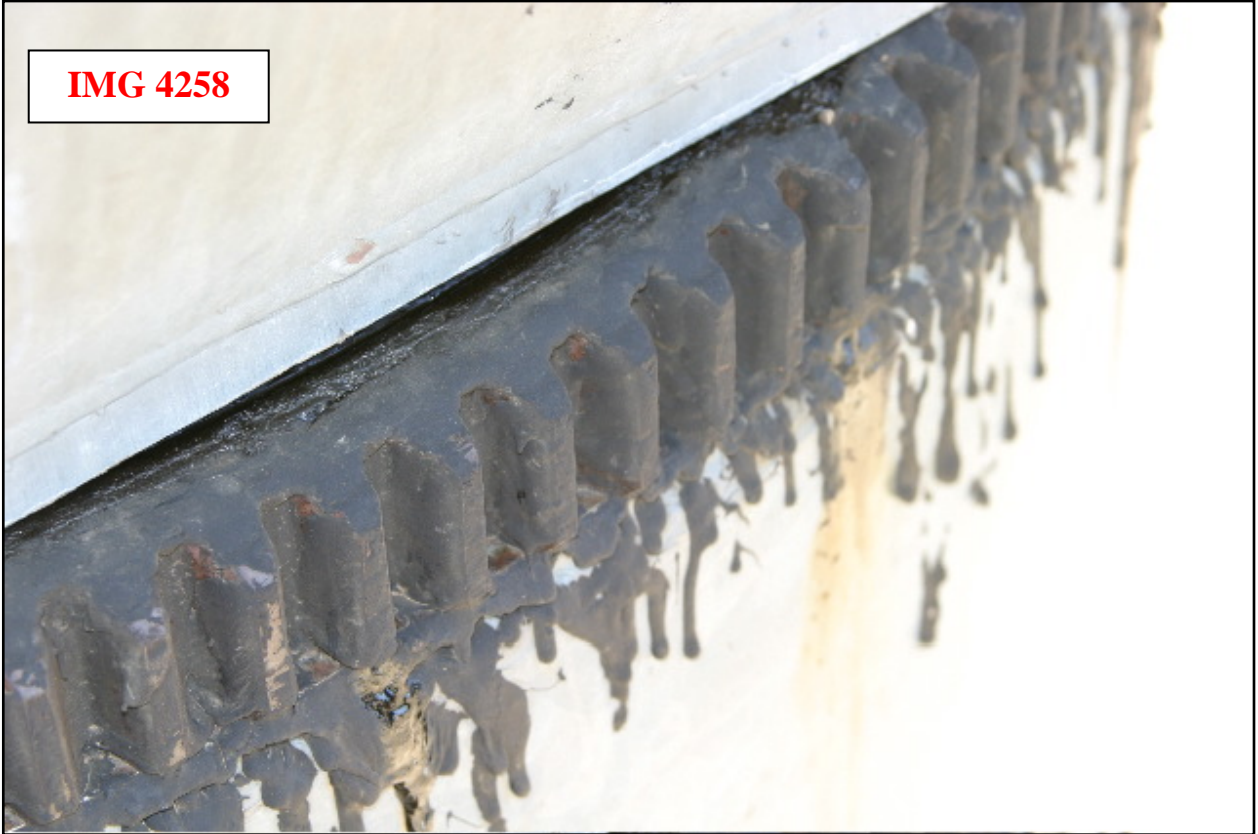
IMG 4258

The nacelle bull gear and slew ring shows some wear on the prevailing upwind side of the gear (where the gear drive spent most of its operational life) but the rest of the gear (IMG 4258) has been well lubricated and appears to be in a good condition. EMS suggest complete replacement of the bull gear assembly. As well, the yaw drive has experienced a total failure (IMG 4282). There are 4 captured socket head cap screws 20MM in diameter that hold the yaw drive gear train to the nacelle, 2 of the 4 bolts have been broken off so the yaw drive cannot be re attached unless those bolts are repaired (requires removal of the nacelle). The yaw pinion gear is stripped (IMG 4260) out in the middle where it connects to the reduction drive. The gear reduction drives and drive motors appear to be complete and in good working condition.

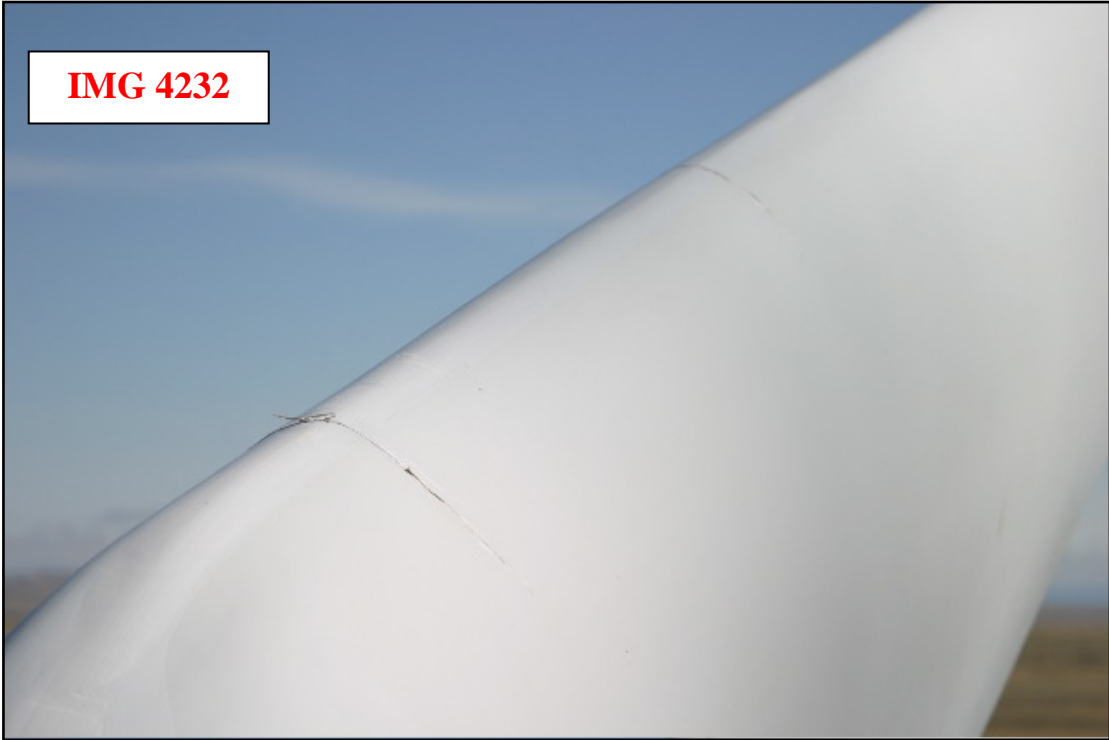
IMG 4232

Of the three blades on the turbine one appears to be in good condition while two have visible surface damage. The blade with the most damage has 2 cracks along the chord about 20 inches apart 36 inches from the root of the blade; they are each about 18 inches long and about 1/8 in wide (IMG 4232). The cracks have been filled with sikaflex (IMG 4238) in the past and will need repair. It also has a longitudinal crack (IMG 4234) where the whale tale meets the root. This crack is 8" long and hasn't split open yet. The last

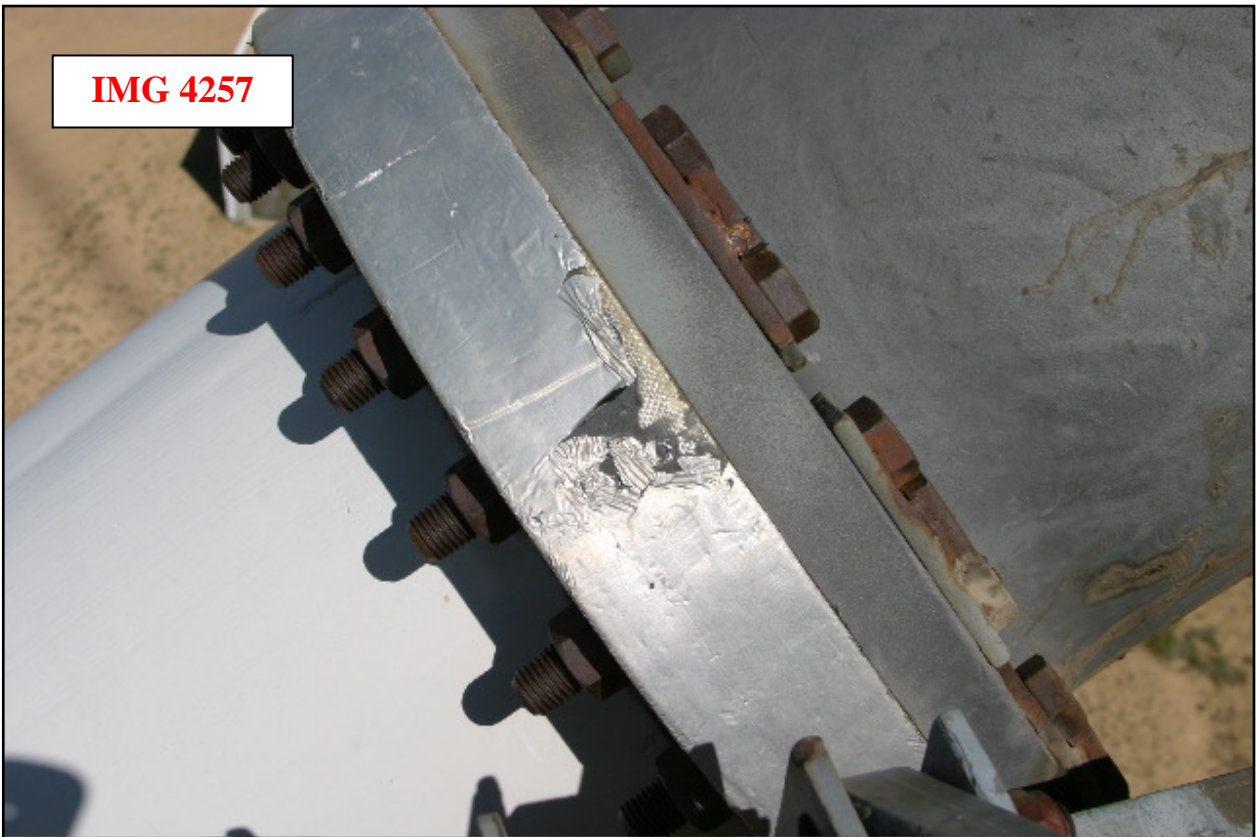
IMG 4257

There was no fiberglass powder present near the root of the blades. There is a spot on one of the blades (IMG 4257) where the fiberglass root pack is exposed to the elements but there doesn't seem to be any damage to the area other than possible UV damage.

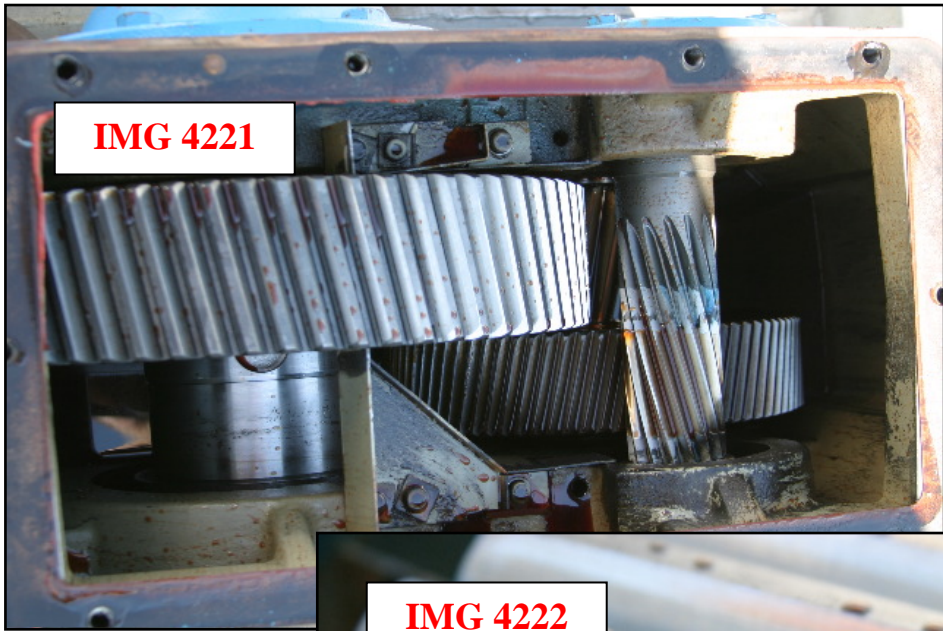
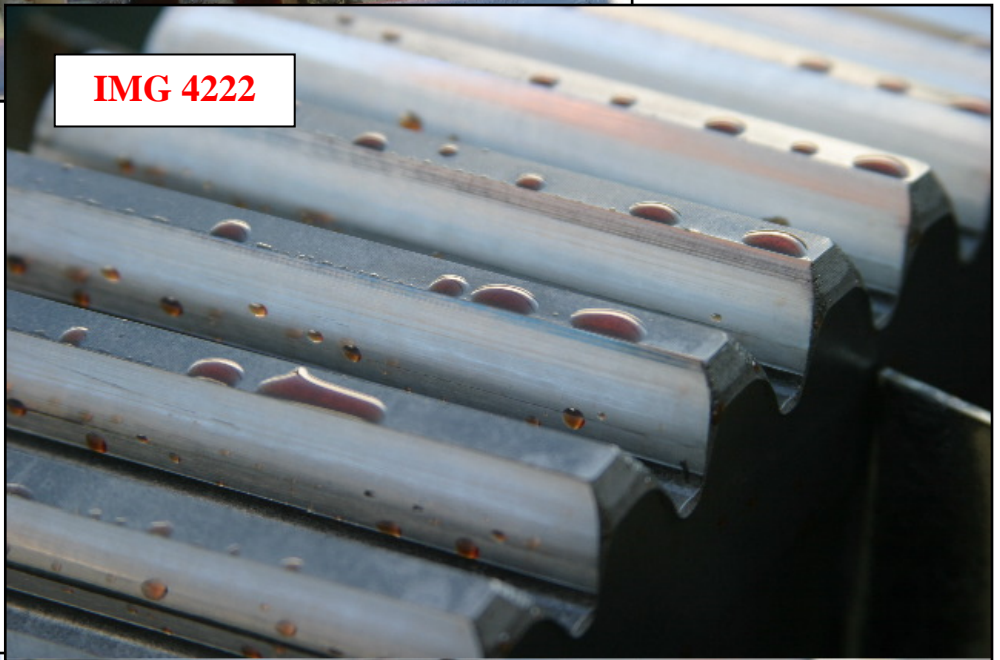
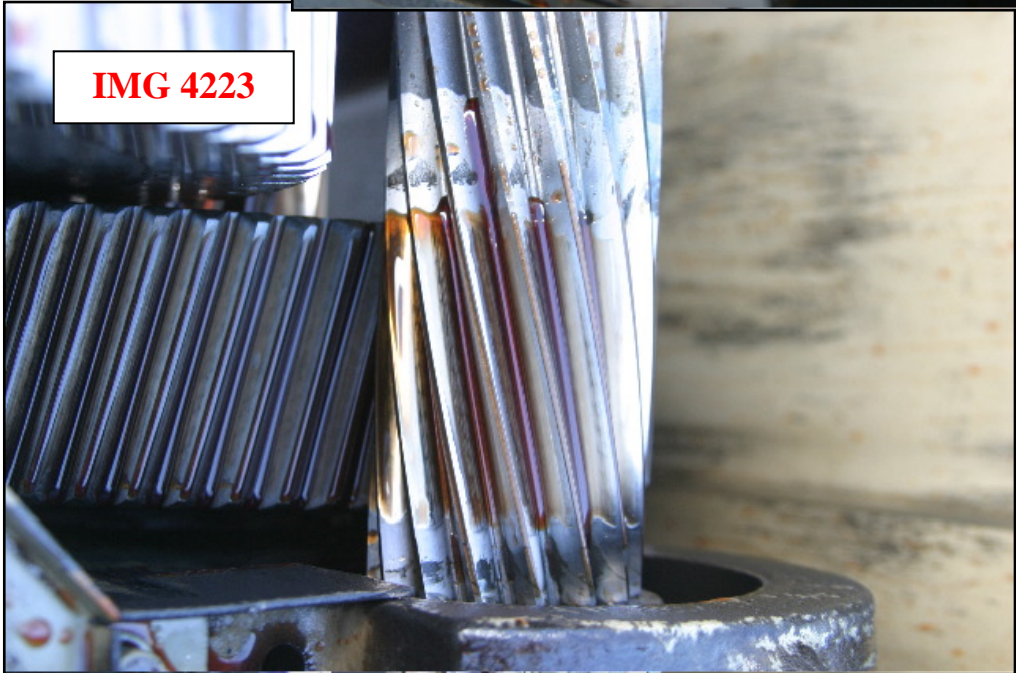
The gears and bearings appear to be in excellent condition (IMGS 4221, 4222 & 4223). There is approximately 2 to 5 roughly 2-5degrees of backlash on the high-speed shaft. The gear teeth were all wearing evenly on both sides. This wear is consistent with similar wear on turbines that have motored down wind. The gear box, couplers and low speed shaft operate without any unusual noises. The gearbox appears to have a heater installed but was inoperable when inspected.

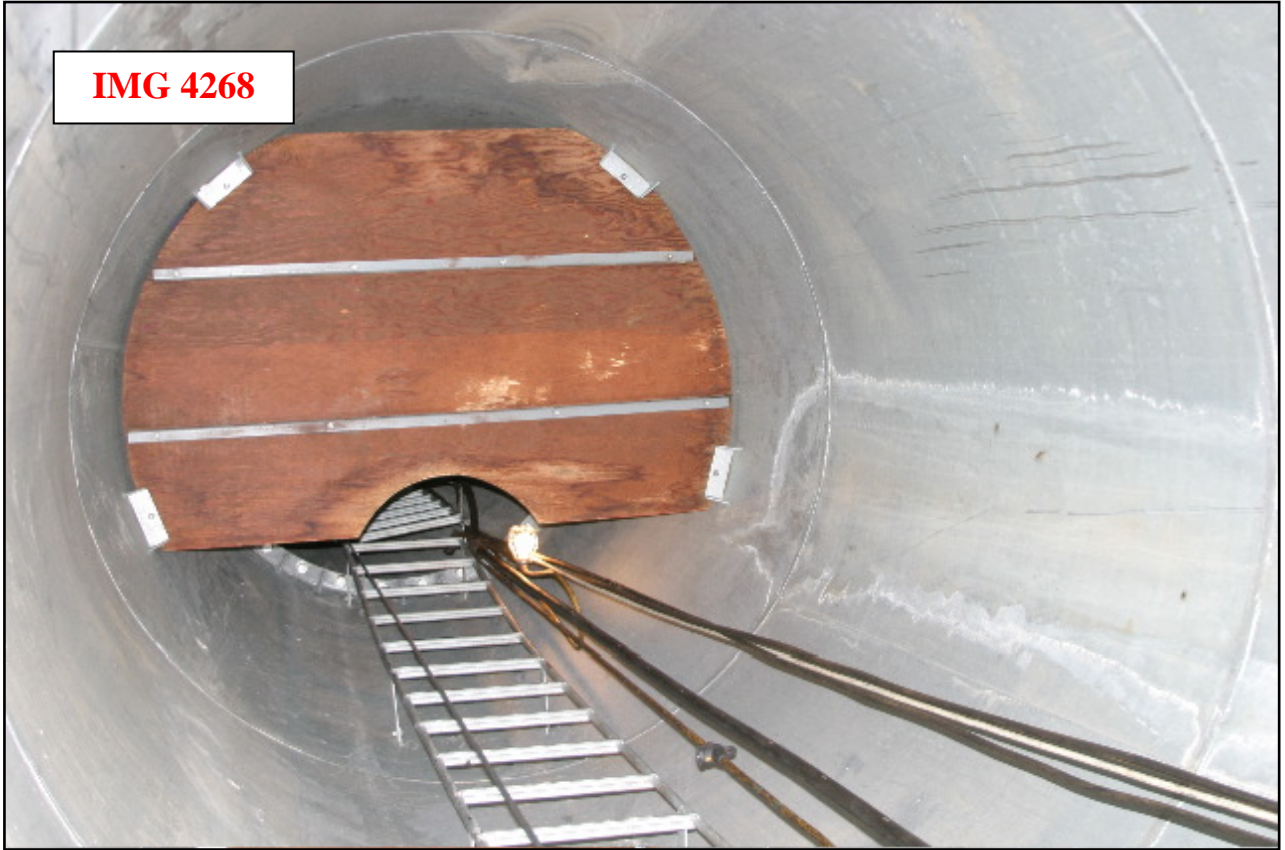
IMG 4268

The ladder and safety cable are in good condition. The ladder is a slightly bent at the tower joints due to the tower being assembled without paying attention to ladder alignment (IMG 4268). The ladder is off by a bolt-hole or two but is otherwise safe to climb. The tower landings are made of plywood. The lower tower landing could use some extra reinforcement. There is a substantial amount of grease and oil at the top of the tower from the years of yaw bearing greasing. The safety cable appears to be in good condition.
